2019 Asset Renewal Program Preliminary Solutions

Stakeholder and Customer Presentation – May 2, 2019

Arcadian Substation –
Needs and Alternatives Analysis Detail
Estimated Cost - \$28M
2023 ISD

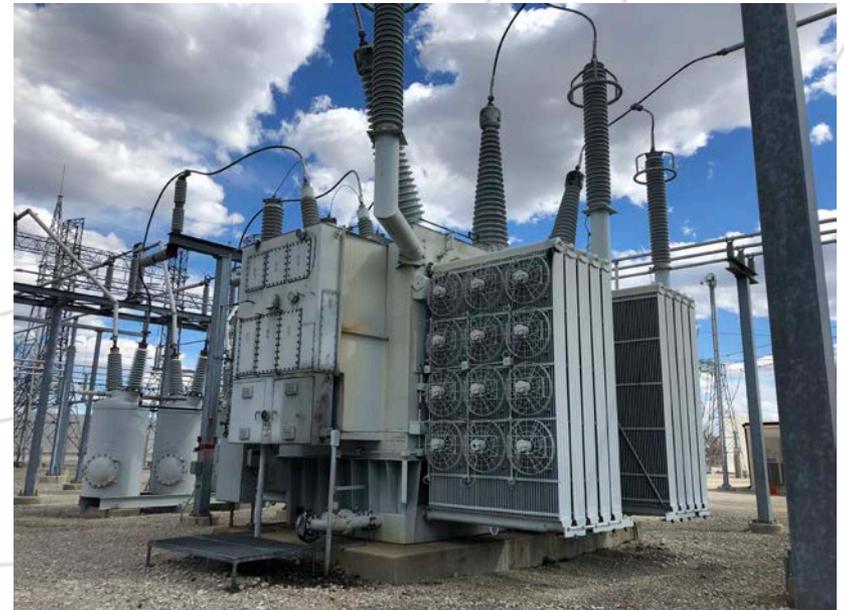
Power Transformers

2 1971-vintage Westinghouse Transformers

- Design
 - Tank gasket design is prone to oil leaks and expensive repairs
 - Main winding design is prone to gassing
- Dissolved Gas Analysis
 - Gases in oil are increasing on T3; indicates insulation deterioration within the transformer
- Bushings
 - Type “O”, history of oil leaks in test tap area, gaskets at end of life, power factor increasing on some bushings indicating insulation nearing end of life
 - Bushings are 20+% of transformer failures
- Load Tap Changers
 - Compartment and driveshaft seals developing oil leaks in the past 5 years
 - Regulated tertiary voltage, only two left of this voltage on the ATC system
 - Non-typical installation and no longer needed point of failure
 - LTC’s are high contributors to many transformer failures
- Transformers have been exposed to tertiary through-faults which contributes to failures
- Lack of oil containment for environmental controls

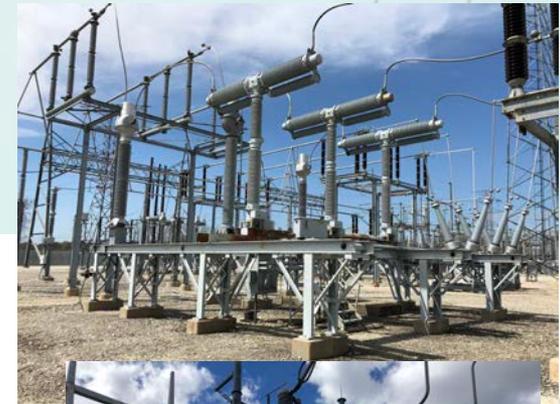
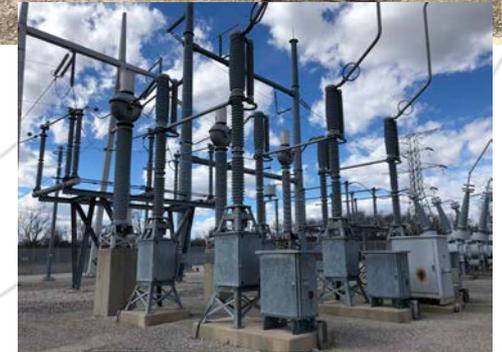
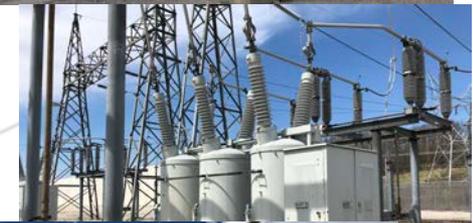
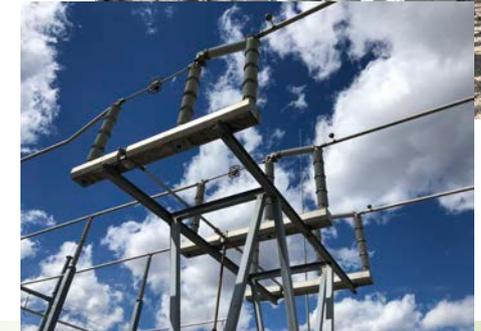
Breakers / Circuit Switcher

- 345kV
 - 2 1982-vintage Allis Chalmers LPO-362 SF6 Breakers
 - Live tank breaker leaves protection gaps in design
 - No longer supported by the manufacturer

- Parts not available
 - 1 1984-vintage Delle Alsthom FX362-22 Gas Breaker
 - Live tank breaker leaves protection gaps in design
 - No longer supported by the manufacturer

- Parts not available
 - Craft experience is limited for troubleshooting and maintenance
 - 1 1970-vintage S&C Mark II Circuit Switcher
 - Cannot be used for fault clearing– overduited and inadequate design for clearing a fault.

- Parts not available
 - Craft experience is limited for troubleshooting and maintenance.
- 138kV
 - 2 1970-vintage Allis Chalmers model BZO oil breakers

- Hydraulic mechanism is prone to trouble callouts for loss of close energy (failure to operate)
 - Craft experience with the PH-33E-5 hydraulic mechanism is limited for troubleshooting and maintenance

- Ohio Brass “GK” bushings have been good performers but have power factor results trending higher, indicating insulation deterioration

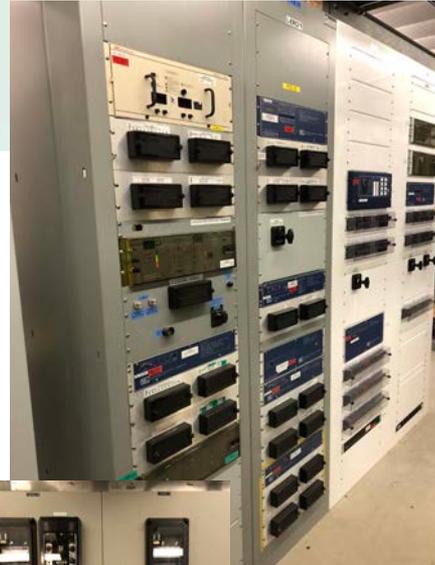
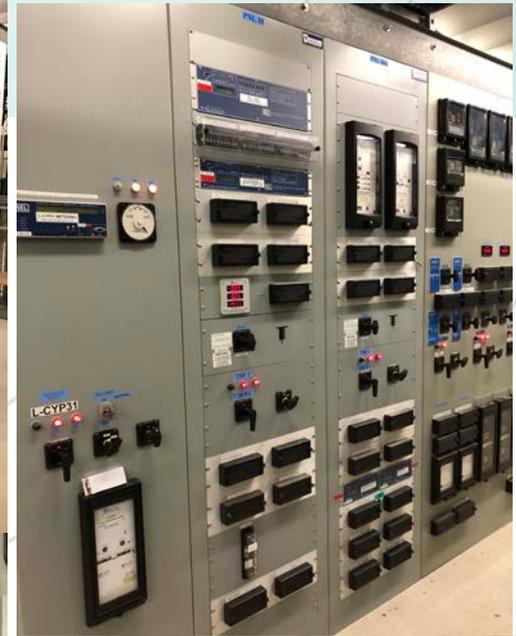
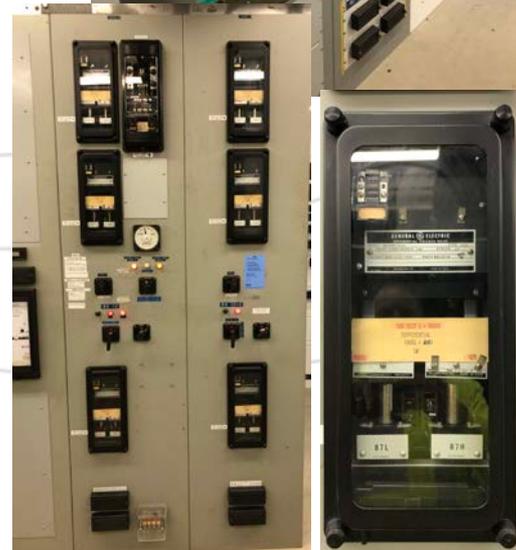
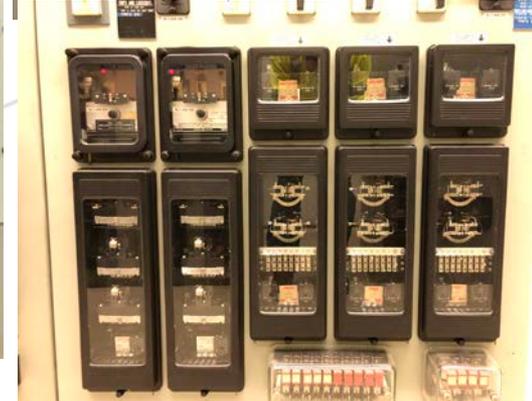
Line, Bus and Transformer Relay Panels

- 26 panels with relays

- 34 electromechanical relays
 - Obsolete technology and improved protection with the newer relaying technology
 - Do not support fault locating, oscillography, or remote access for troubleshooting and fault analysis
 - Parts are no longer available
 - Originally installed in 1972
- 11 solid state relays
 - Relays will fail without alarming to EMS/SCADA
 - Obsolete technology and improved protection with the newer relaying technology
 - Do not support fault locating, oscillography, or remote access for troubleshooting and fault analysis
 - Parts are no longer available
- 34 microprocessor relays
 - Microprocessor relays have a 25-year life of power supply and internal capacitors.
 - Obsolete technology and improved protection with the newer relaying technology

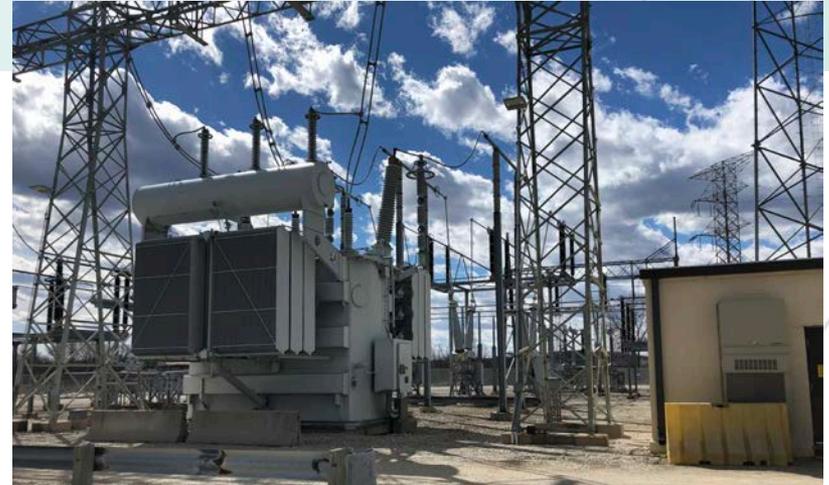
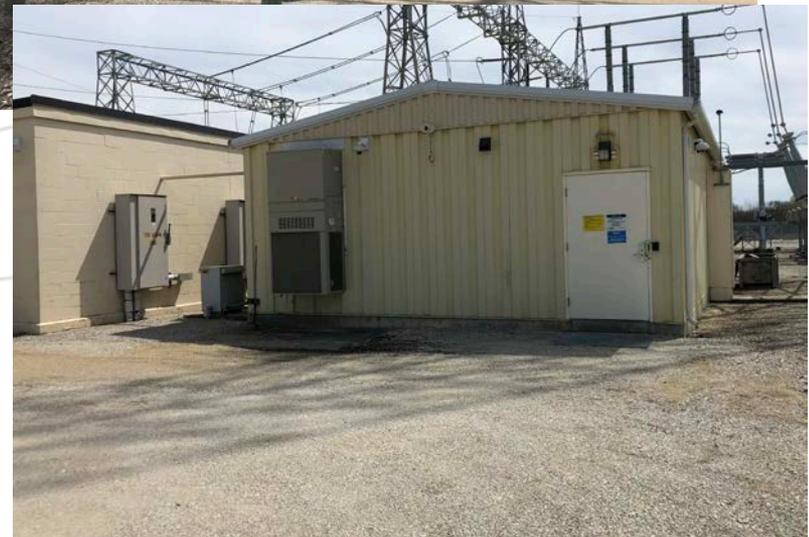
Protection and Control Building

- Inadequate design for severe weather and physical security
- Control cabling to the yard are at end of life
- Close proximity of existing building to power transformer and need for oil containment
- Inadequate and poor performing HVAC and insulation systems
- Inadequate and poor performing AC building wiring systems
- Construction cost efficiencies when replacing relays at the same time

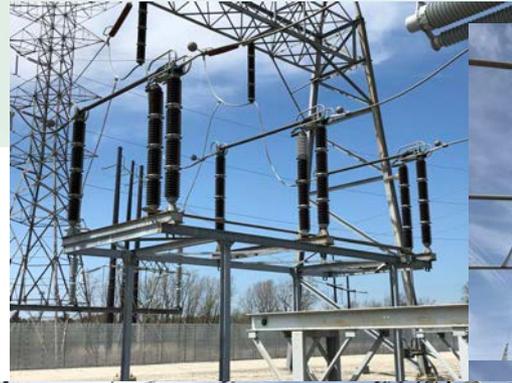
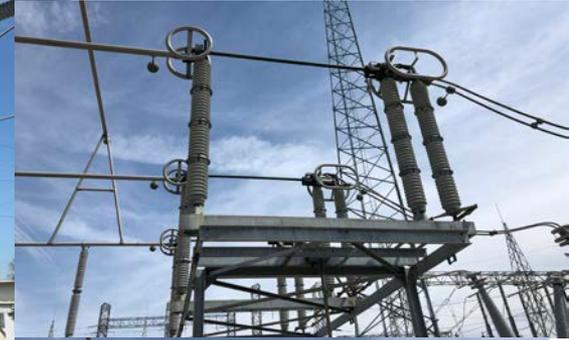
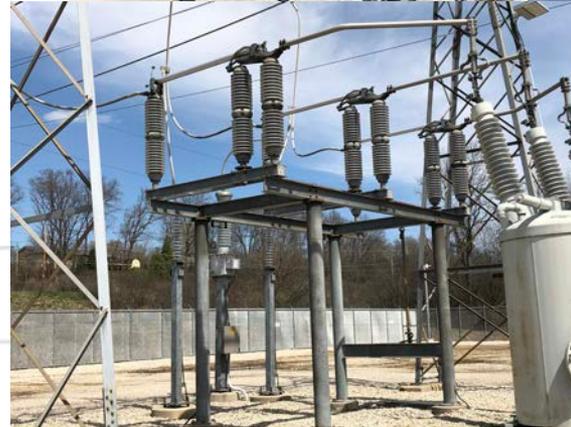
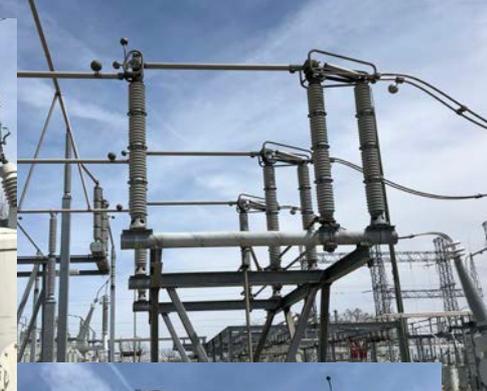
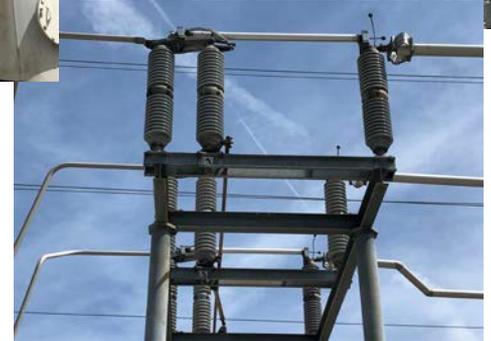
Disconnect Switches

- 345kV
 - 5 Schwager Wood TA-3A Switches
 - Parts are not available
 - 1 Westinghouse V-2 Switch
 - Develop hot spots
 - 1 ITE TTR-6 Switch
 - Develop hot spots
 - Become difficult to operate inoperable near end of life
- 138kV
 - 5 Allis Chalmers ATA-2A Switches
 - Parts are not available
 - 1 Siemens AVB Switch
 - Parts are not available

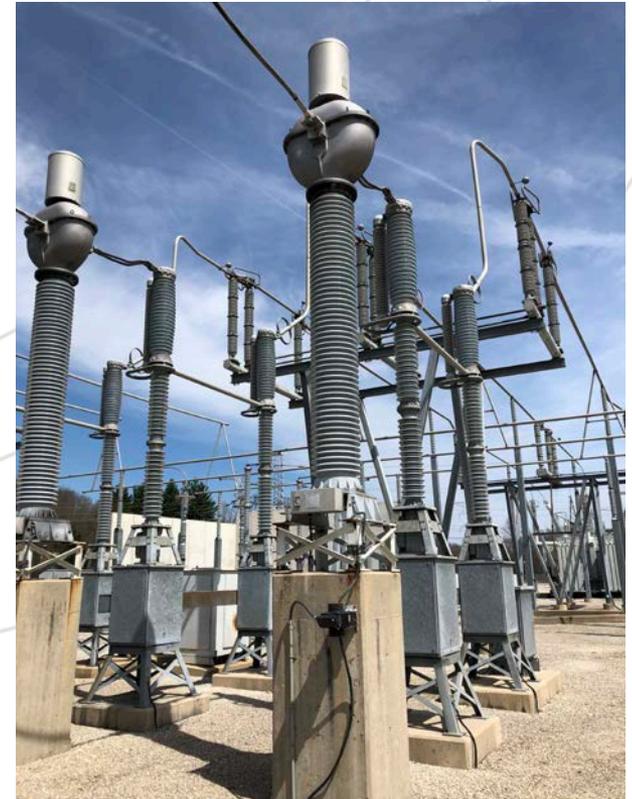
Instrument Transformers

- 3 1983-Vintage Trench OSKF-1300 Current Transformers
 - This particular vintage has a high failure rate (factory manufacturing start up issues)
 - Prone to moisture ingress and failure to operate relays properly
 - Design is inadequate and has a gap in protection

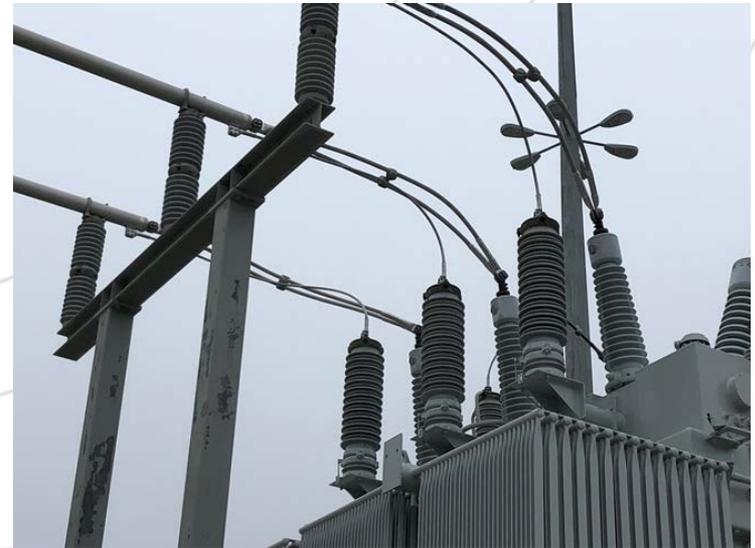
Arresters and Insulation Systems

- **345kV and 138kV**
 - 6 Ohio Brass MPR transformer arresters
 - Silicon Carbide arresters do not protect equipment effectively
 - Moisture seals are at end of life. Arrester failure can be catastrophic and take out other elements (bushings, etc.)
 - Industry replacement on average is 40 years; these arresters are beyond that timeframe
 - Bus Insulation is under evaluation. Typically expect the system to perform reliability for 50 years.
